Introduction

360° Product Testing has been retained to conduct impact testing of the client's athletic cups plus cups from two competitors; see the photo to the right. From left to right:

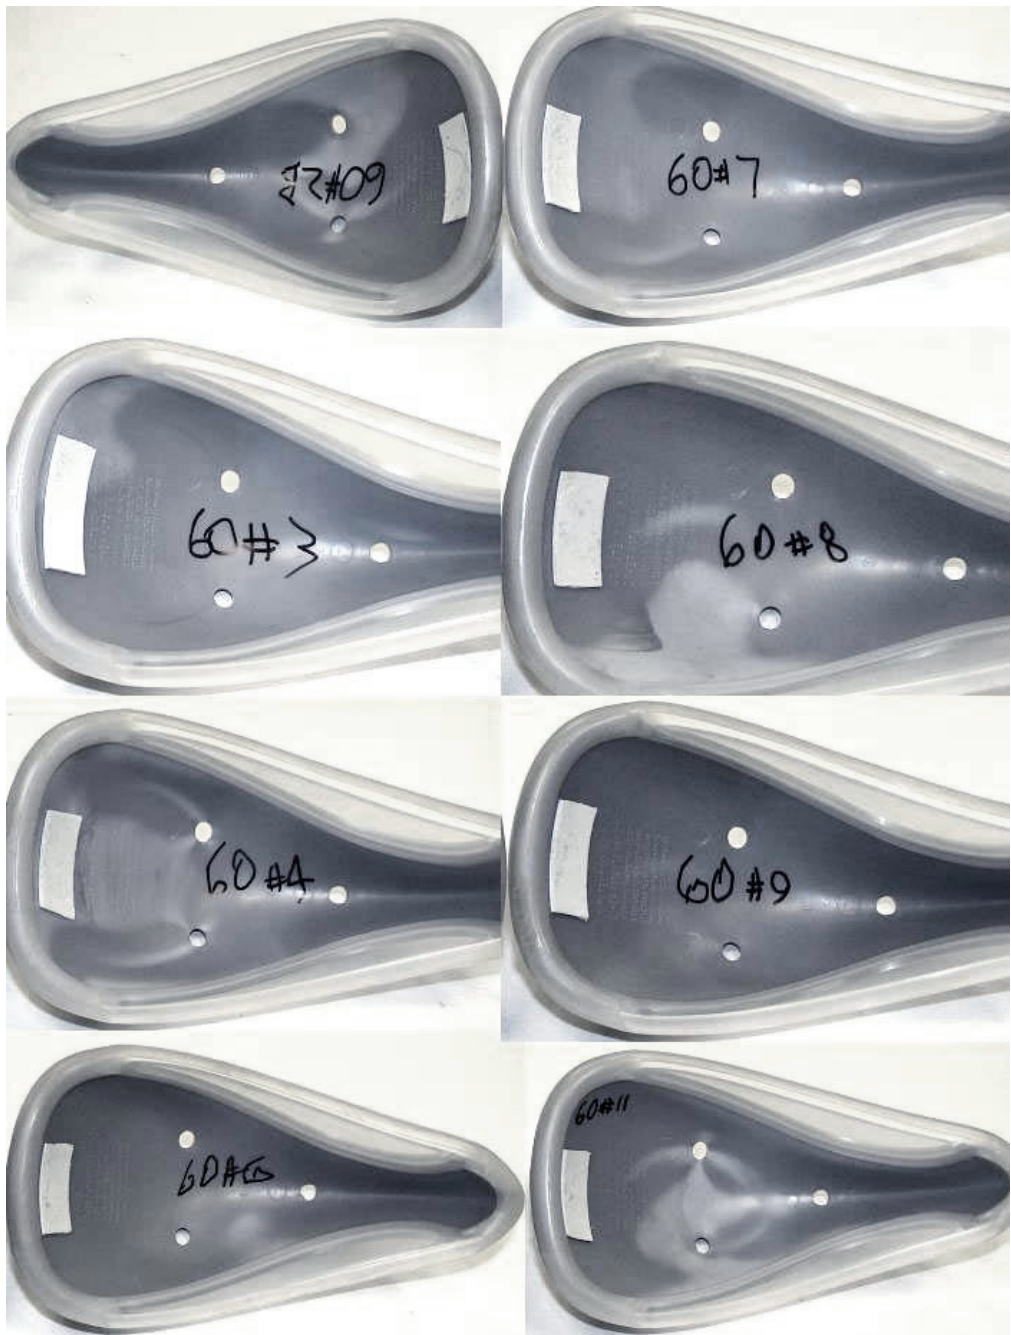
- When struck on the relatively flat upper surface of the cup, Brand - 3 cup - C compressed within the area struck by the ball and usually showed stress marks visible on the inside of the cup where it had deformed. The ball would often leave a visible mark on the exterior surface of the cup, on the opposite side of the stress mark. Stress marks were not generally visible on the outside of the cup except around ventilation holes. One cup appeared to crack but the cracks appear to be inside the plastic; no break in the material can be felt on either the inside or outside. What appears to be a small crack in one cup may not actually be a crack, however, since there is neither any feeling of a break in the plastic, nor a stress mark around the crack. As seen in the photo on the following page, most of the Brand - 3 cups, after being struck at 60 mph, show highly visible stress marks on the interior surface.

Impact stress marks on Brand - 3 cups struck at 60 mph

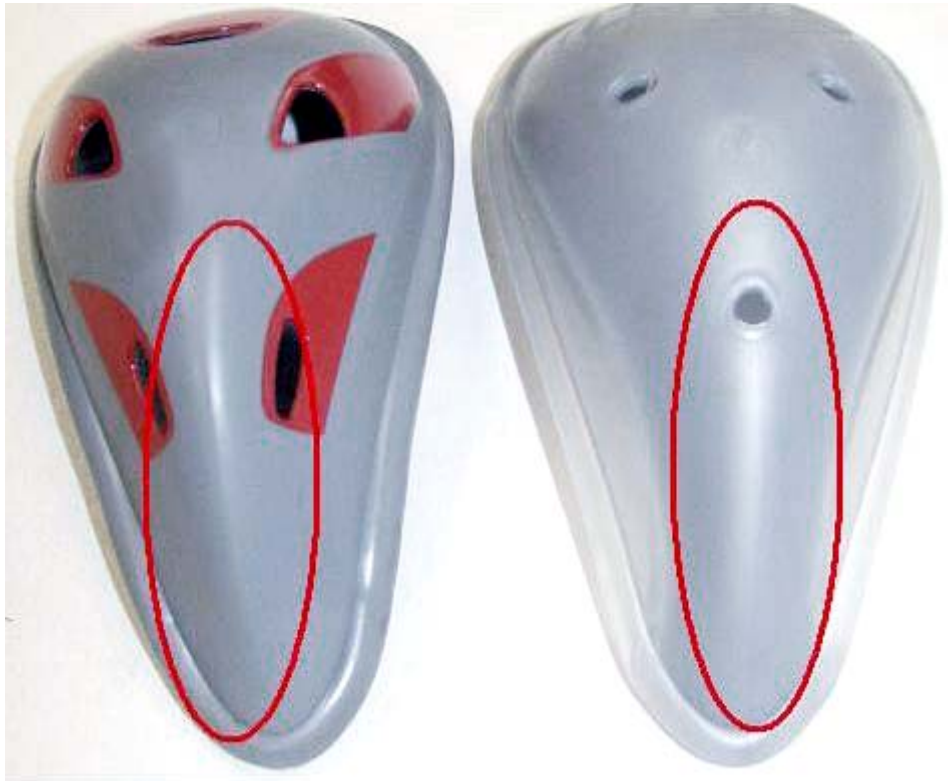
- Brand - 1 cups have a relatively-flat surface on the “upper” portion of the cup, but with a sharper “ridge” on the lower portion of the cup compared to the Brand - 3 cup - C (below).

In the photo above, note the sharper “ridge” in the center of the lower portion of the Brand - 1 cup - A on the left, compared to the relatively-blunt “ridge” on the Brand - 3 cup - C on the right. Note, too, that the upper portion of each of these two cups is relatively “flat”. This allows a ball, striking the center of the upper portion of either cup, to continue to compress the cup rather than rolling off to either side. Note, for example, in the following photo series, how the ball compressed into the Brand - 1 cup before finally rolling off and down the side of the cup. A Brand - 3 cup - C also deformed but the ball would then tend to “bounce” away from the cup rather than roll down the side.

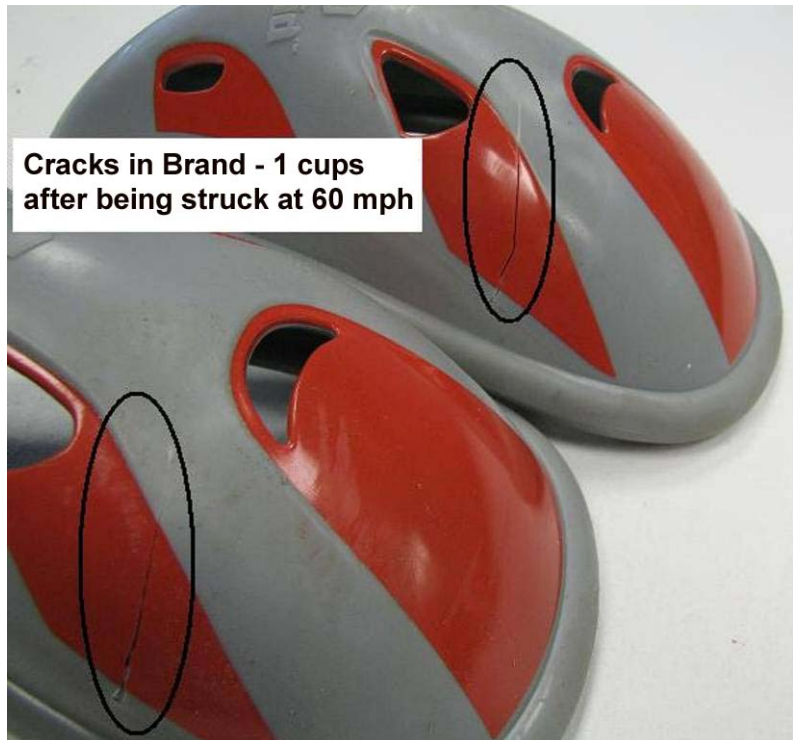
- Two Brand - 1 cup - A cups cracked when struck at 60 mph; the photo series above shows one of those two cups. The ball struck each cup at almost the same location, just to the right and slightly above the center. The photo at right shows the almost-identical cracks in the two Brand - 1 cups.

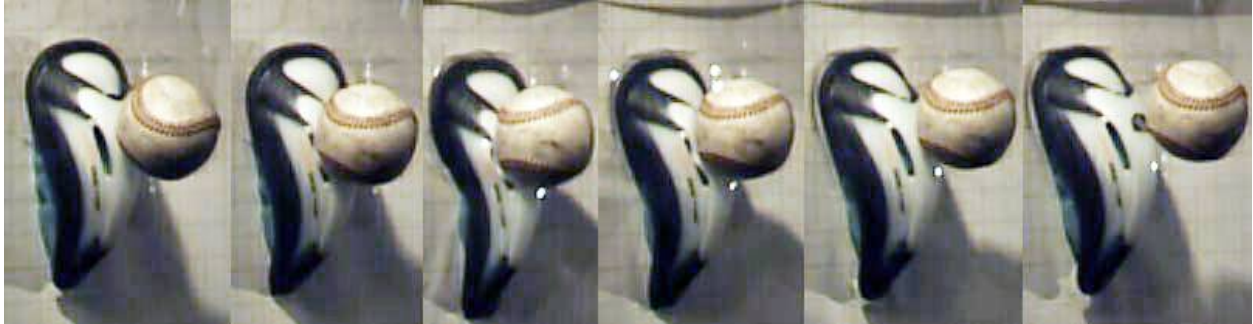
- When struck at only 30 mph, the Brand - 2 cup - B noticeably deformed, as seen in the following photo sequence.

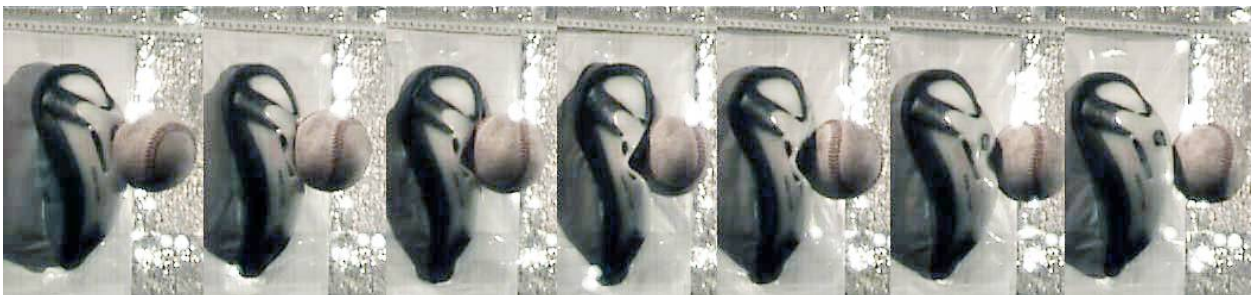
- Another 60 mph strike on a Brand - 2 cup, slightly off center, caused the cup to deform inward where it was struck, as seen in the following photo sequence. The ball is clearly following the shape of the cup and rolling off to the side, where it might have struck the cup-wearer’s body.

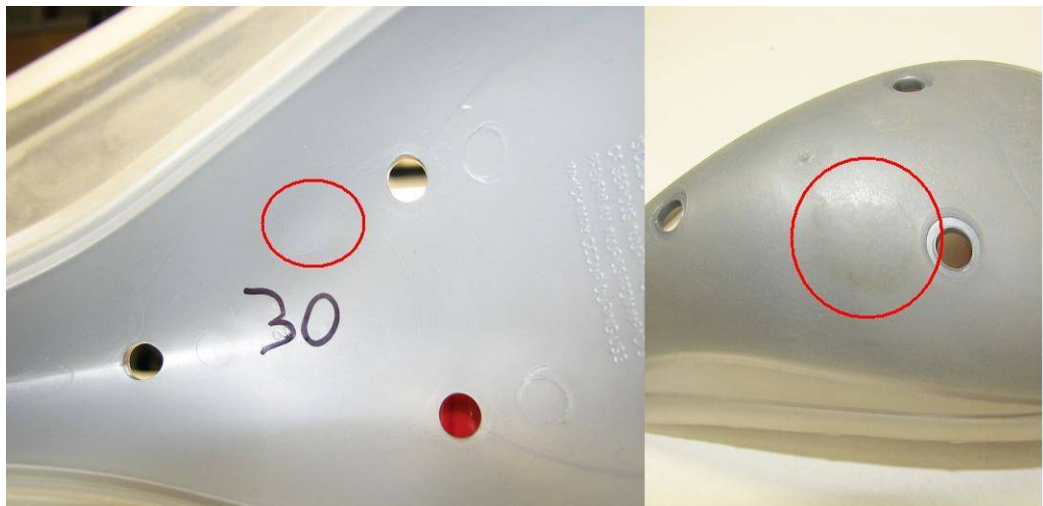
This particular strike left a barely-discernable stress mark on the inside of the cup. The ball left a much-more-visible “wear mark” on the outside (pictured below).

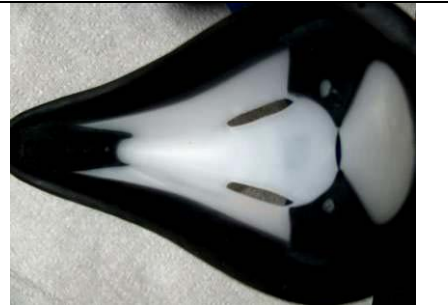
After three (3) impacts at the equivalent 60 mph setting, the Brand - 2 cupl did not show any signs of fatigue, stress, or cracking.

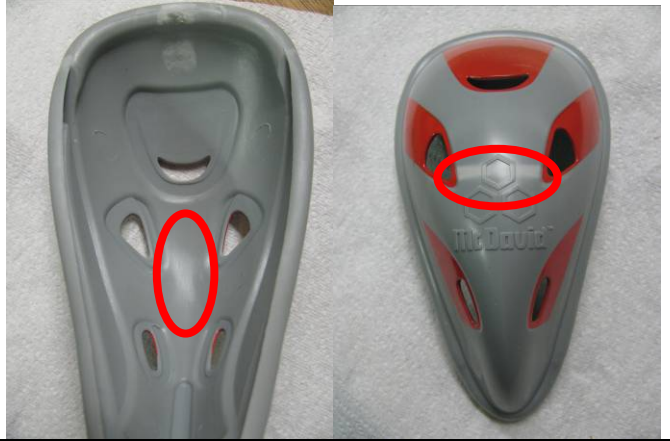
<p>60mph damage:</p> <p>After one hit on the first sample, very visible stress fatigue marks appeared between the ventilation holes. The plastic stress marks are visible on both the inside and outside of the cup. The 60 mph baseball impact created the same fatigue pattern.</p>

The red and gray Brand - 1 cup - A consistently displays stress flexure marks between ventilation holes when impacted by a 60 mph ball (or equivalent). This is due to the local plastic area exceeding the plastic strength. This can be improved with slightly additional thickness or plastic additive. This device generally absorbs the most energy of the products tested.

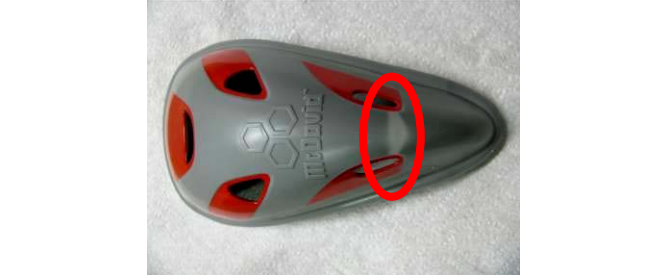
<p>60mph damage:</p> <p>The single impact on the second sample landed slightly lower. The same behavior of the plastic stress mark immediately appeared between the lower ventilation holes.</p>

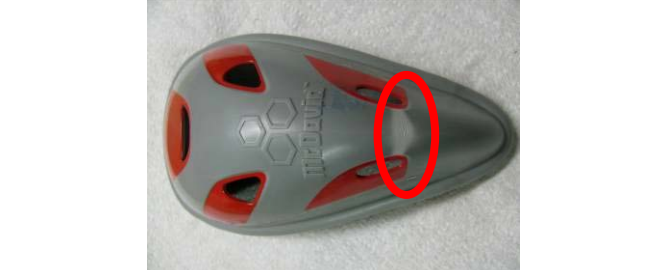
<p>60mph damage:</p> <p>The single impact on the third sample landed slightly lower than the impact on the second sample; but the stress marks that appeared look almost identical to those on the second sample.</p>
