## Introduction

360° Product Testing has been retained to perform functional, durability testing and analysis upon provided Brand mixers, as shown to the right. This testing included:

The following presents 360° Product Testing's findings for the branded mixer.<sup>1</sup>

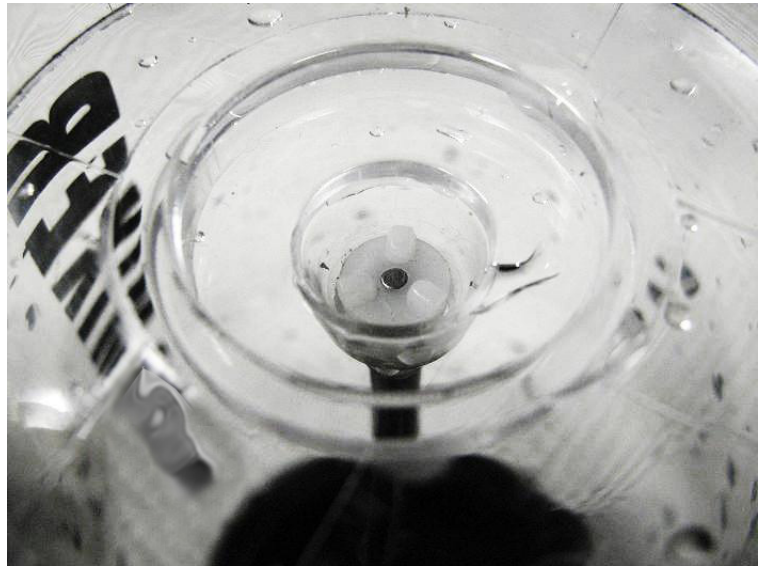
When first tested, the mixer stirrer of CM02 would not rotate at all, and the stirrer of CM03 rotated very erratically. Later, after the concoction-mixing tests, close examination revealed that the pinion gear might be pressed too far onto the stirrer shafts, causing the stirrers to bind; see the photo at right.

In response, engineers pressed out the steel shaft by about 0.010” on CM02, which then allowed the stirrer to be easily spun by hand (by reaching into the cup) with less friction. After this “adjustment”, the motor to able spin the stirrer.

In fact, the difference is such that CM02 achieved the highest motor RPM of the three when stirring 8 fl. oz. of water, 16,667 RPM. In contrast, CM01 spun only 40% of that speed while CM03 spun about half the speed of CM02. This spacing of the pinion gear on the stirrer shaft seems to vary somewhat between the three MM units due to slight differences in the silicone gland seal mounted under the stirrer, inside the cup. This seal prevents liquids from leaking down the shaft.

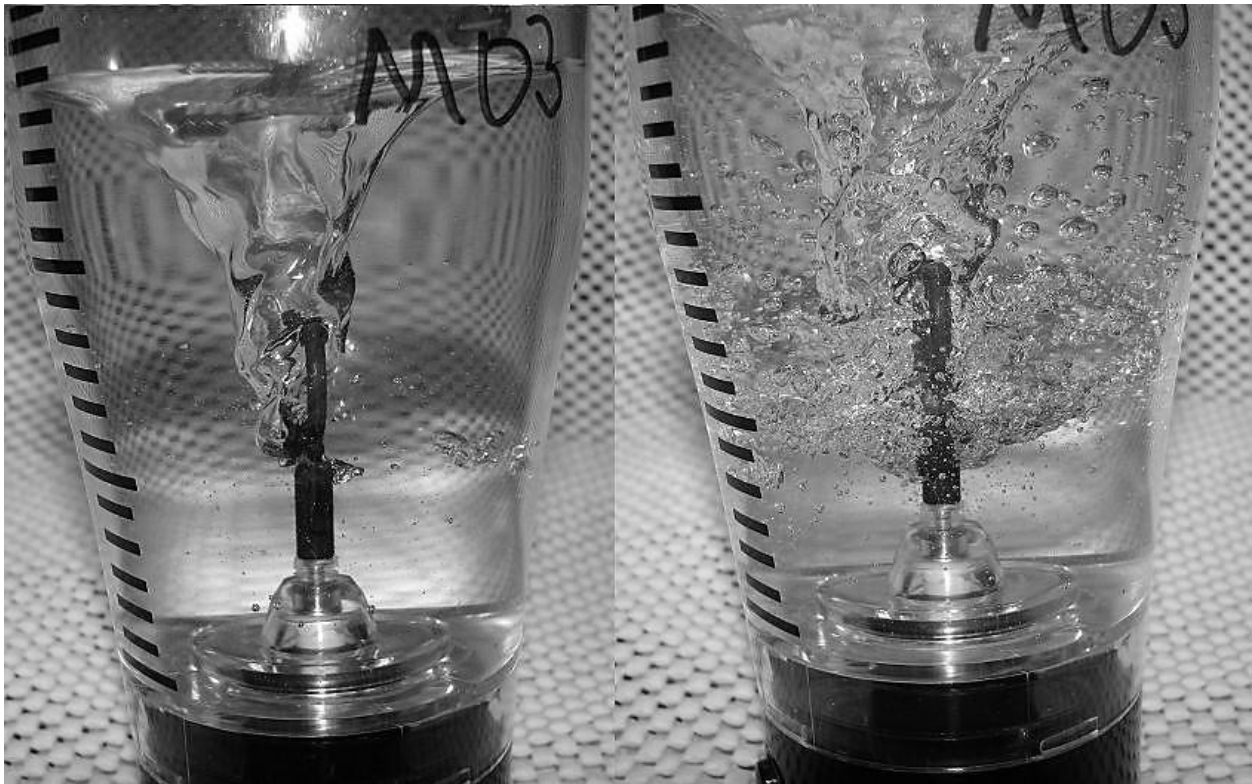
It should be noted that when the mixer is first turned on and the stirrer is spinning at slow speed, there is no vortex with air mixing taking place and this increases the load on the motor; thus, at minute 0, the current can be seen to be highest. After the stirrer has attained sufficient speed as to cause vortex with air, the current then drops since the motor is doing less work. The following two pictures of CM03 illustrate the difference between vortex only and vortex with air mixing.

As the stirrer begins rotating, the rotating motion of the stirrer causes the liquid to rotate within the cup, which gradually causes a vortex to begin forming downward from the surface of the liquid. As the vortex stretches down to and reaches the stirrer, the stirrer mixes air drawn from the vortex into the liquid, then the lower arms of the stirrer toss the air around in the liquid. As air is tossed outward from the stirrer's lower arms, air-mixing occurs which causes the stirrer to encounter less liquid and more air, thus causing less mechanical resistance. The reduction in spinning-resistance lessens the torque requirement on the motor, allowing it to spin faster. The turbulence of the air being mixed in the liquid causes a constantly changing torque on the stirrer which causes the motor speed to jump up and down as the arms of the stirrer alternately encounter air and liquid.

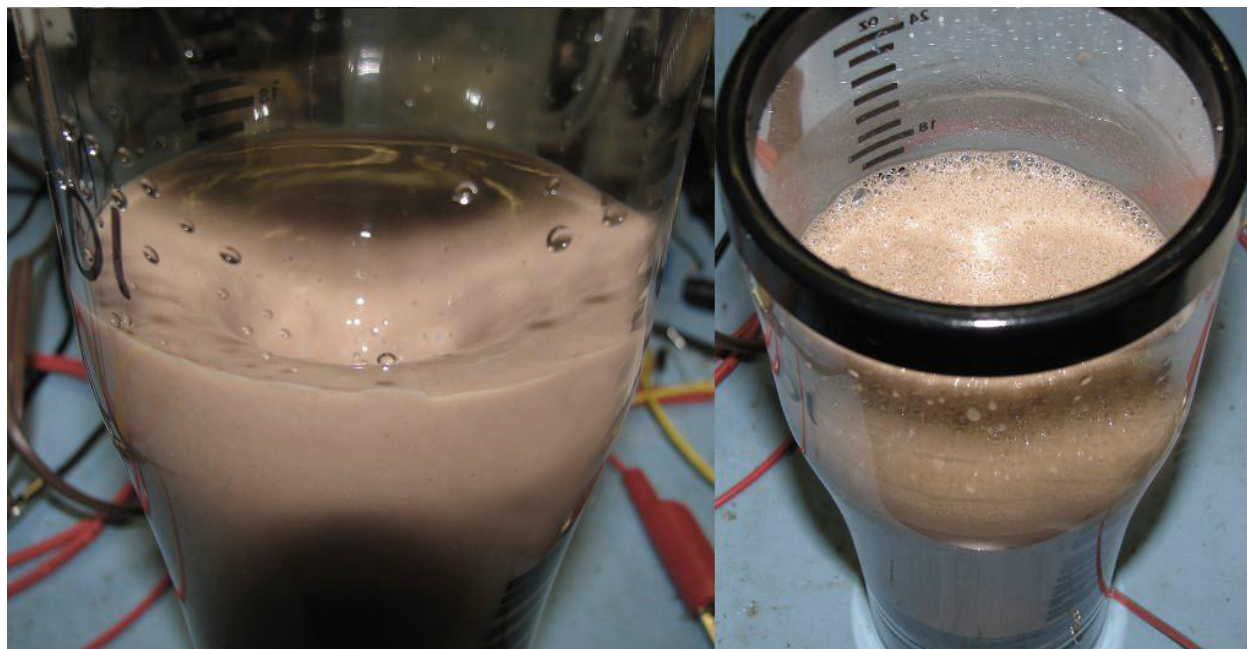
Thus, while mixing the concoction, motor current remained much higher than was the case while stirring a thinner liquid such as water. When mixing 8 fluid ounces of concoction using CM01, 360° observed the motor current at 1.9 amperes while the power supply held the voltage to the motor constant at 3.14 volts. The rotational speed appeared to be about 1500 RPM, considerably slower than when mixing the same volume of water. While a vortex did form, the vortex apparently never brought enough air down to the stirrer to allow vortex with air to begin (had vortex with air begun, the motor would have drawn less current, thus extending battery life). The left-hand photo below shows a clear vortex formed while the concoction was being mixed; the right-hand photo illustrates the thoroughness of the mixing process after two minutes.

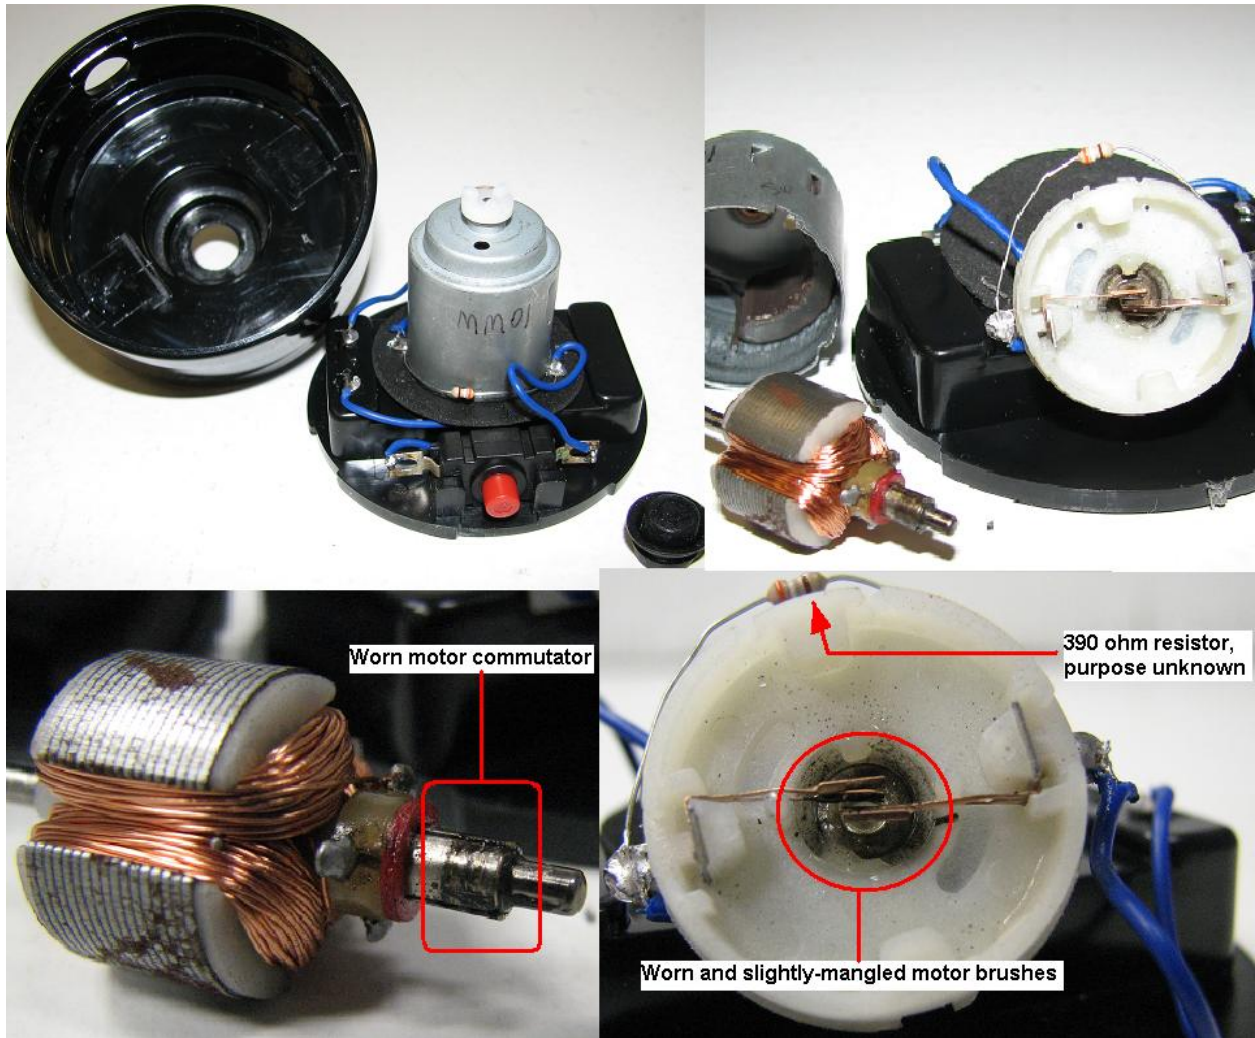
The DC motor used in the Brand mixers is a standard 2-pole, 3-coil type, as shown in the photos on the following page. The pictured motor is from CM01 and has been operated off-and-on, with liquid and without, for about 45 minutes. It is already showing signs of wear on the commutator and brushes; note the uneven edges on the sides of the three commutator pieces, and the bent motor brushes. Although a slight amount of bending of the brushes occurred when the motor was disassembled, there is also some bending of one brush that could not have occurred during assembly or disassembly. The end of the motor shaft that rides inside a bronze bushing also shows signs of wear.

A 390-ohm resistor can be seen mounted across the motor terminals on the exterior; the purpose of this resistor is unknown, but will cause a small amount of current (approximately 7 milliamperes at 3.0 volts) to be drawn while power is being applied to the motor. A resistor across the motor terminals will not affect any commutator-brush sparking, whereas a small capacitor might reduce such sparking.

No manufacturer or part number markings were found on the motor (the CM01 seen was written on the motor case for ID purposes).

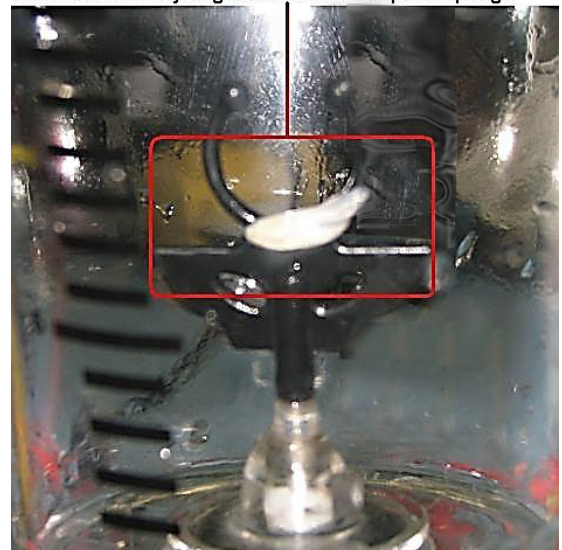
The mixer cup is a thick polystyrene casting. Unlike a standard household blender, however, the bottom portion holding the stirrer cannot be removed for cleaning. The narrow cup's depth makes it difficult for a large hand to reach inside with a sponge or other appliance to wipe off the stirrer or bottom of the cup. When eggs are mixed with the Brand mixers, portions of the liquid embryo tend to get wrapped around the stirrer, as seen in the photo at right.

Egg embryo wrapped around mixer stirrer that did not wash away with water. To clean this off, it was necessary to gently dab at the relatively-fragile stirrer with the tip of a sponge.

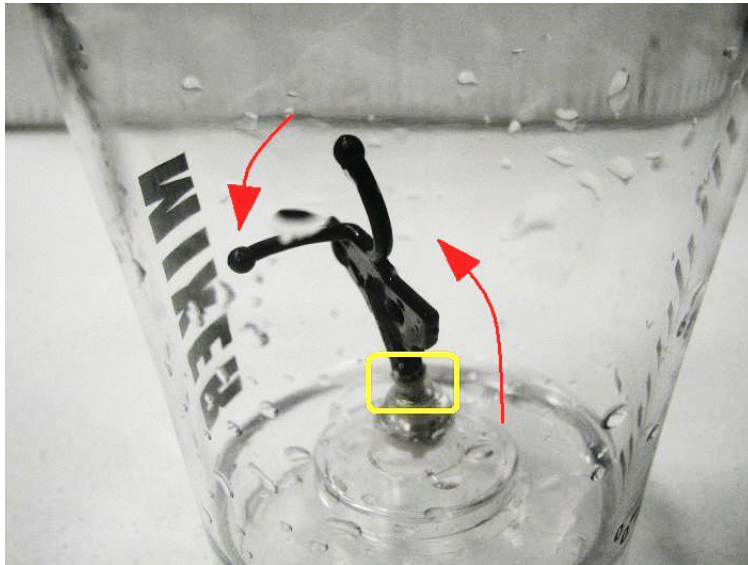
Underneath the black mixer stirrer is a silicone gland that provides the liquid-tight seal around the mixer shaft. However, **after about 30 to 40 minutes of intermittent use, the silicone gland on CM01 began leaking water**, which ran down the stirrer and then the motor shaft. Close examination of the other two mixers also found several drops of water in the motor compartment of CM03; CM03 had approximately 20 minutes of intermittent (usually about 2 minutes each) usage.

The yellow rectangle highlights where the silicone liquid-tight gland is located.

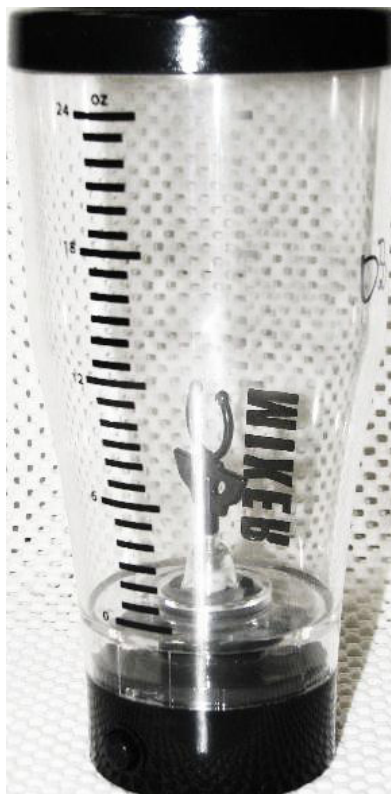
Engineers purposely applied force to the mixer stirrer in several ways to try to induce it to break; however, the stirrer simply bent, as seen to the left. First, the upper “tong” was pressed sideways and down; then pressure was applied perpendicular to the stirrer shaft on the large black plastic of the stirrer, which caused the steel stirrer shaft to bend to the left.

Based on these tests, engineers believe the mixer stirrer will survive any kind of soft food that is likely to be placed within the mixer cup. If a food item is too hard, the motor will be unable to provide sufficient torque as to break up the food, thus preventing damage to the stirrer.

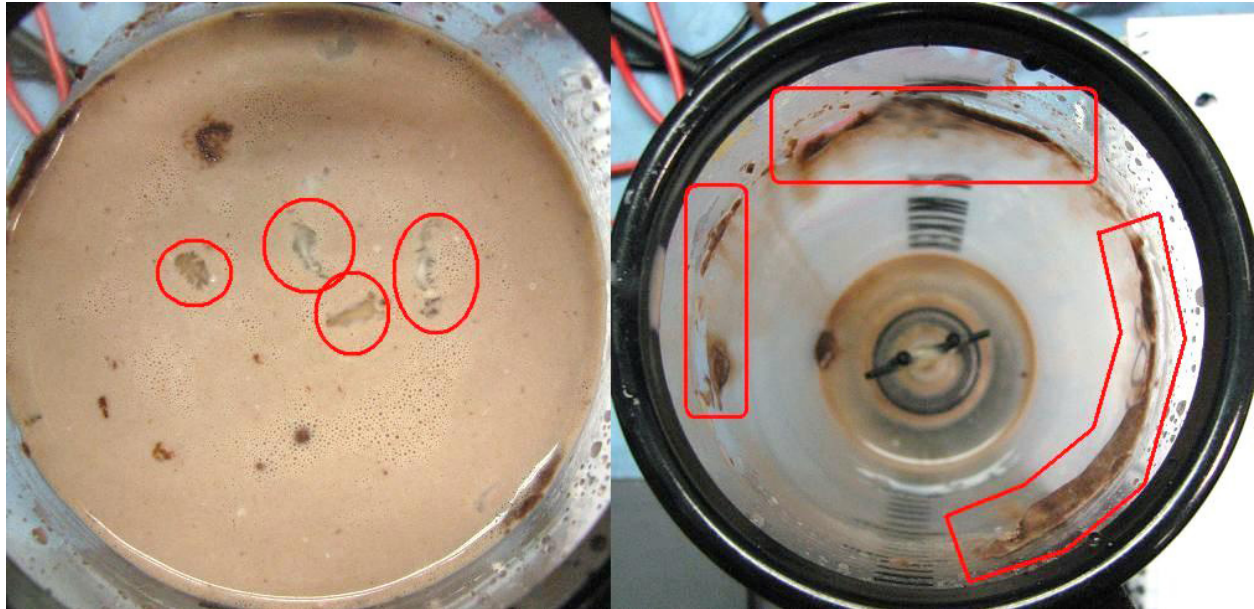
Engineers found that for best mixing performance, only 8 fluid ounces liquid should be mixed at a time within the MM cups. During 360°'s first concoction mix, engineers attempted mixing 12 fluid ounces of milk, but the rest of the concoction ingredients were as previously described. This turned out to be too much liquid, and the stirrer was unable to draw a deep vortex that caused the materials to be stirred properly. As a result, after 2 minutes of mixing, there were still pieces of egg visible on the top of the concoction, as seen in the red highlighted areas in the photo to the left below.

In addition, if a powdered mix is to be mixed with liquid, the mix should be dropped into the cup and the cup slightly stirred/agitated to let the mix sink below the surface of the liquid. If the powder is allowed to sit on top of the liquid when the mixer is turned on, the powder can become deposited on the walls of the cup, as seen in the above right-hand photo within the highlighted areas. Mixing only 8 fluid ounces at a time, and making certain the powder mix has sunken below the surface of the liquid, results in the nicely-mixed concoction seen earlier.
