Introduction

360° Product Testing has been retained to conduct impact testing of the client's athletic cups plus cups from two competitors; see the photo to the right. From left to right:

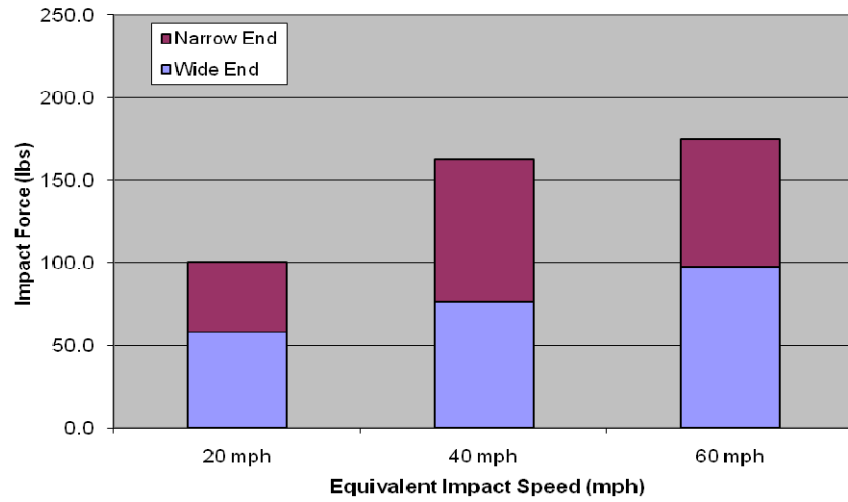
Brand - 3

<p>60mph damage:</p> <p>The plastic regions near and between the ventilation holes show signs of plastic strain. These areas are the higher stress points that will likely be the first points of any failure or cracking.</p>

<p>60mph damage:</p> <p>The second gray sample, after three (3) impacts at 60 mph, suffered a crack along the centerline from the lowest hole toward the narrow tip.</p>

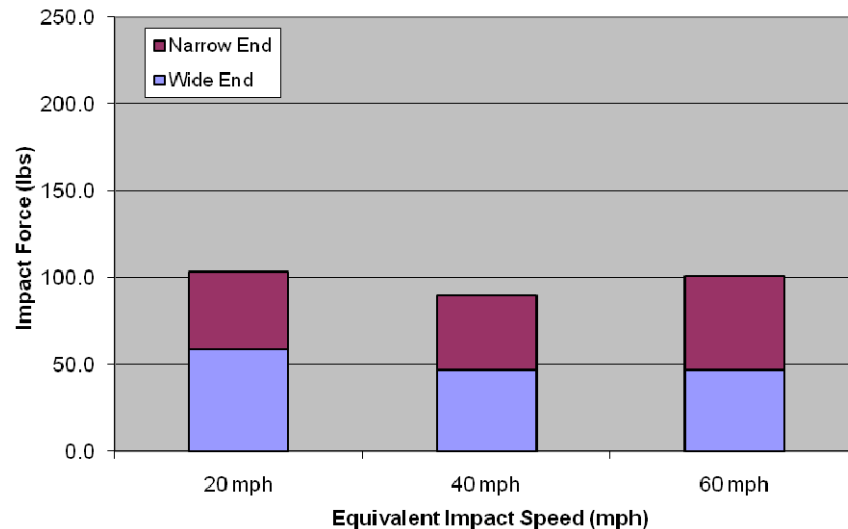
The same weighted object was dropped from various heights onto the Brand - 2 sample cups. The measured heights correspond to the impact energy of an equivalent speed baseball. There was no observable damage from any of the impact simulations. The highlights of the product damage are summarized below.

After three (3) impacts at the equivalent 60 mph setting, the Brand - 2 cupl did not show any signs of fatigue, stress, or cracking.

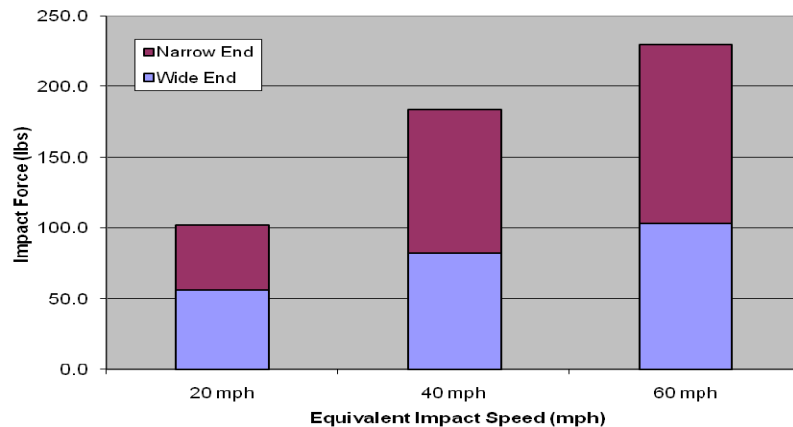
Brand - 1

<p>60mph damage:</p> <p>After one hit on the first sample, very visible stress fatigue marks appeared between the ventilation holes. The plastic stress marks are visible on both the inside and outside of the cup. The 60 mph baseball impact created the same fatigue pattern.</p>

<p>60mph damage:</p> <p>The single impact on the second sample landed slightly lower. The same behavior of the plastic stress mark immediately appeared between the lower ventilation holes.</p>

<p>60mph damage:</p> <p>The single impact on the third sample landed slightly lower than the impact on the second sample; but the stress marks that appeared look almost identical to those on the second sample.</p>

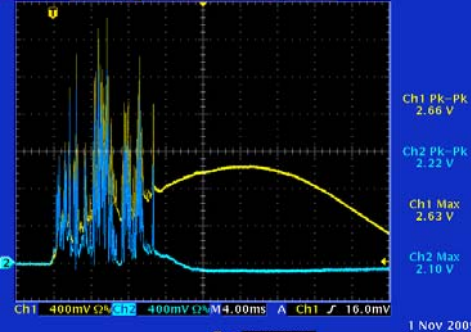
<p>Ch1 Pk-Pk 2.66 V Ch2 Pk-Pk 2.22 V Ch1 Max 2.63 V Ch2 Max 2.10 V 1 Nov 2009 18:33:36</p>	Oscillating impact frequency. Test setup vibration.
